Performance Evaluation on Low-Crest Breakwater at North Coast of Java Island

Parlindungan Sudrajat Simanjuntak

Board of Kalimantan I River Basin, Ministry of Public Works, Pontianak, INDONESIA

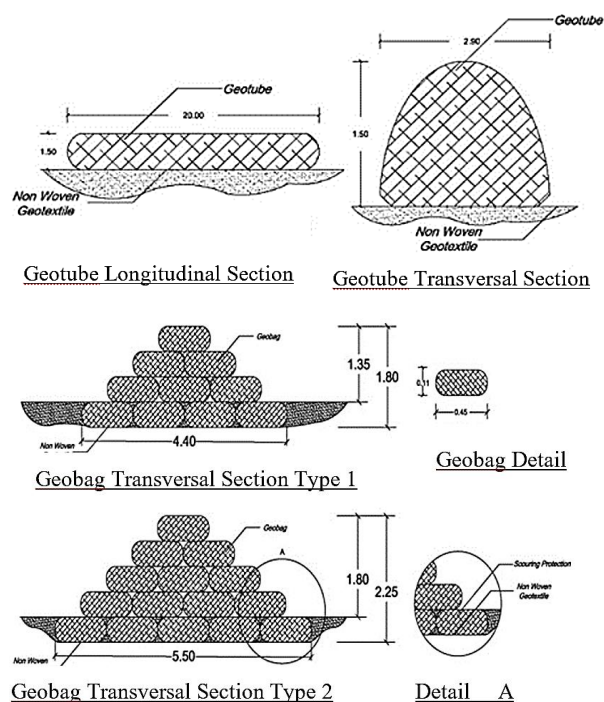
Figure 7. Low-crest Breakwater Construction Structure in Pekalongan City.

Coastal safety structure was installed with scouring protection on depth of ± 0.50 m, with two types of structure, ones with geobag material that was installed on along the shoreline, and the other one that was with geotube geotextile that was installed on ± 20 m offshore at depth of MSL. On the Sari Beach and Slamaran Tourism Beach, the coastal safety was installed with geotube, while on Mangrove Park Beach and Landfill Slamaran Beach, it was installed with two types of coastal safety (Figure 7): the geobag and the geotube. Type of geotube installed was per material with width of 20 m and height of 1.5 m. Geobag was installed on two types, first one was with width of 4.40 m and height of 1.35 m, and second one was with width of 5.50 m and height of 1.80 m.

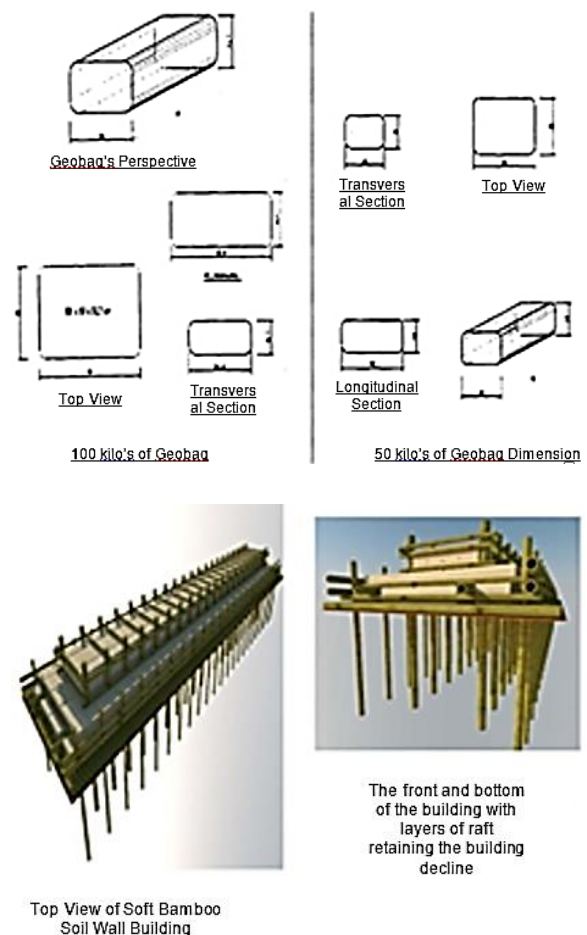
Figure 10. Detailed Drawing on Low-crest breakwater on Demak Regency

Installation of low-crest breakwater in Demak Regency used two different structures. The Hybrid Low-crest Breakwater was installed with bamboo reinforcement, with bamboo length of 4 meter, distance between bamboo of 50 cm, and width of 1 m (Figure 10).

Reinforcement of rope and bamboo crosswise as reinforcement between bamboos, and low-crest breakwater materials was using rock with 10/15 cm of

size as its filler. On structure of geobag low-crest breakwater with bamboo pole, bamboo was used in wide position as the foundation reinforcement, and scouring protection was installed with 50 cm distance between bamboo, and in the longitudinal side, bamboo was installed with 50 cm of distance between bamboo for as long as 80 m on both side. The length of one bamboo foundation was 4.50 m with depth of the stake was 2.50 m.

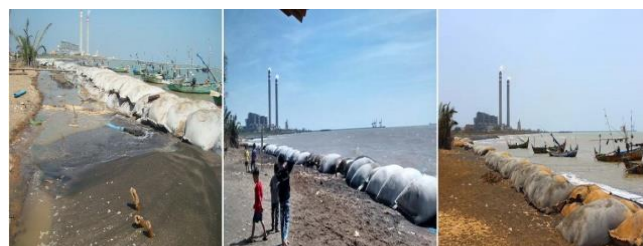
Figure 13. Construction of low-crest breakwater in Jepara Regency

Figure 13 shows the material used in the low-crest breakwater construction which was non-woven geobag filled with local sands. Geobag was placed as high as 2 levels, with foundation digging of as deep as more or less 30 cm, with average width of 2.40 m, and height of about 1 m. Reinforcement of non-woven geotextile material on lower layer as support was implemented in the lower part of the foundation.
